**ROYAL AIR FORCE
PROCEEDINGS OF A BOARD OF INQUIRY
INTO AN AIRCRAFT ACCIDENT**

To inquire into an accident involving NIMROD MR2 XV230 on 2 SEP 06.

CONCLUSIONS OF THE BOARD

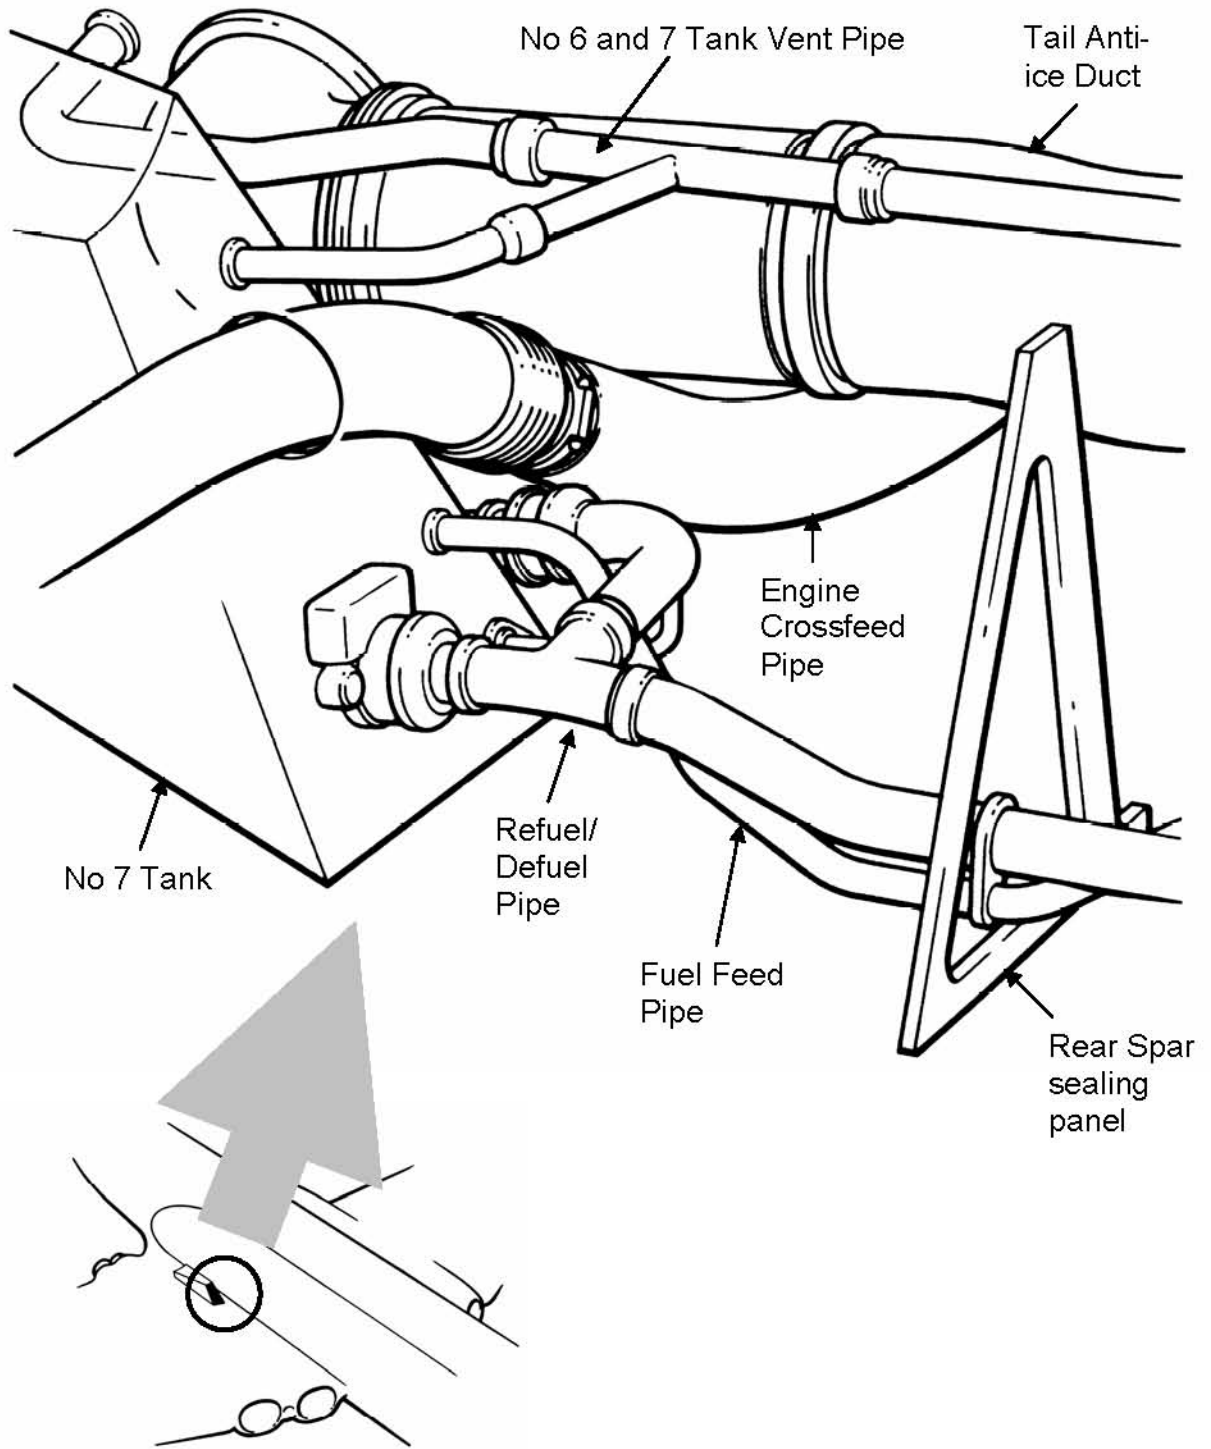
NO 7 TANK DRY BAY

(2) The NSC analysis of Zone 614 (which contains the No 7 tank dry bay) identifies almost identical hazards to those determined by the Board. However, the NSC assessment of the risk imposed by those hazards is significantly different to that assessed by the Board. The NSC quotes the potential for fuel system leakage as 'Improbable', which is defined as 'Remote likelihood of occurrence to just 1 or 2 aircraft during the operational life of a particular fleet'. The Board's analysis of fault data indicates an average of 40 fuel leaks per annum for the Nimrod MR2 fleet between 2000 and 2005. Even in the absence of such data (which is not easily extracted from the sources) a number of incident reports occasioned by fuel leaks have been raised over the years, including one in which leaking fuel falling on the cross-feed duct began to smoke. The NSC states that the cross-feed duct is only pressurised during engine start, not taking into account the lengthy periods it can be pressurised (at a working temperature of up to 420 °C) when feeding the SCP. Furthermore, the NSC notes, as mitigation for the Zone 614 hazards, the provision of an aircraft fire detection and suppression system: neither exist within Zone 614. These inaccuracies led to an overly optimistic assessment of the hazards related to Zone 614, which in turn affected the assessment of the probability of the loss of an aircraft to an uncontrolled fire/ explosion – given as 'Improbable'. In its examination of the NSC the Board focussed principally on those areas of relevance to XV230's loss, but noticed a number of other inaccuracies, not directly related to the investigation. Had the NSC's inaccuracies been noticed earlier, the Board considers that a more intense review of the hazards concomitant on airframe fuel leaks might have been instigated. Moreover, the higher assessed risk, which

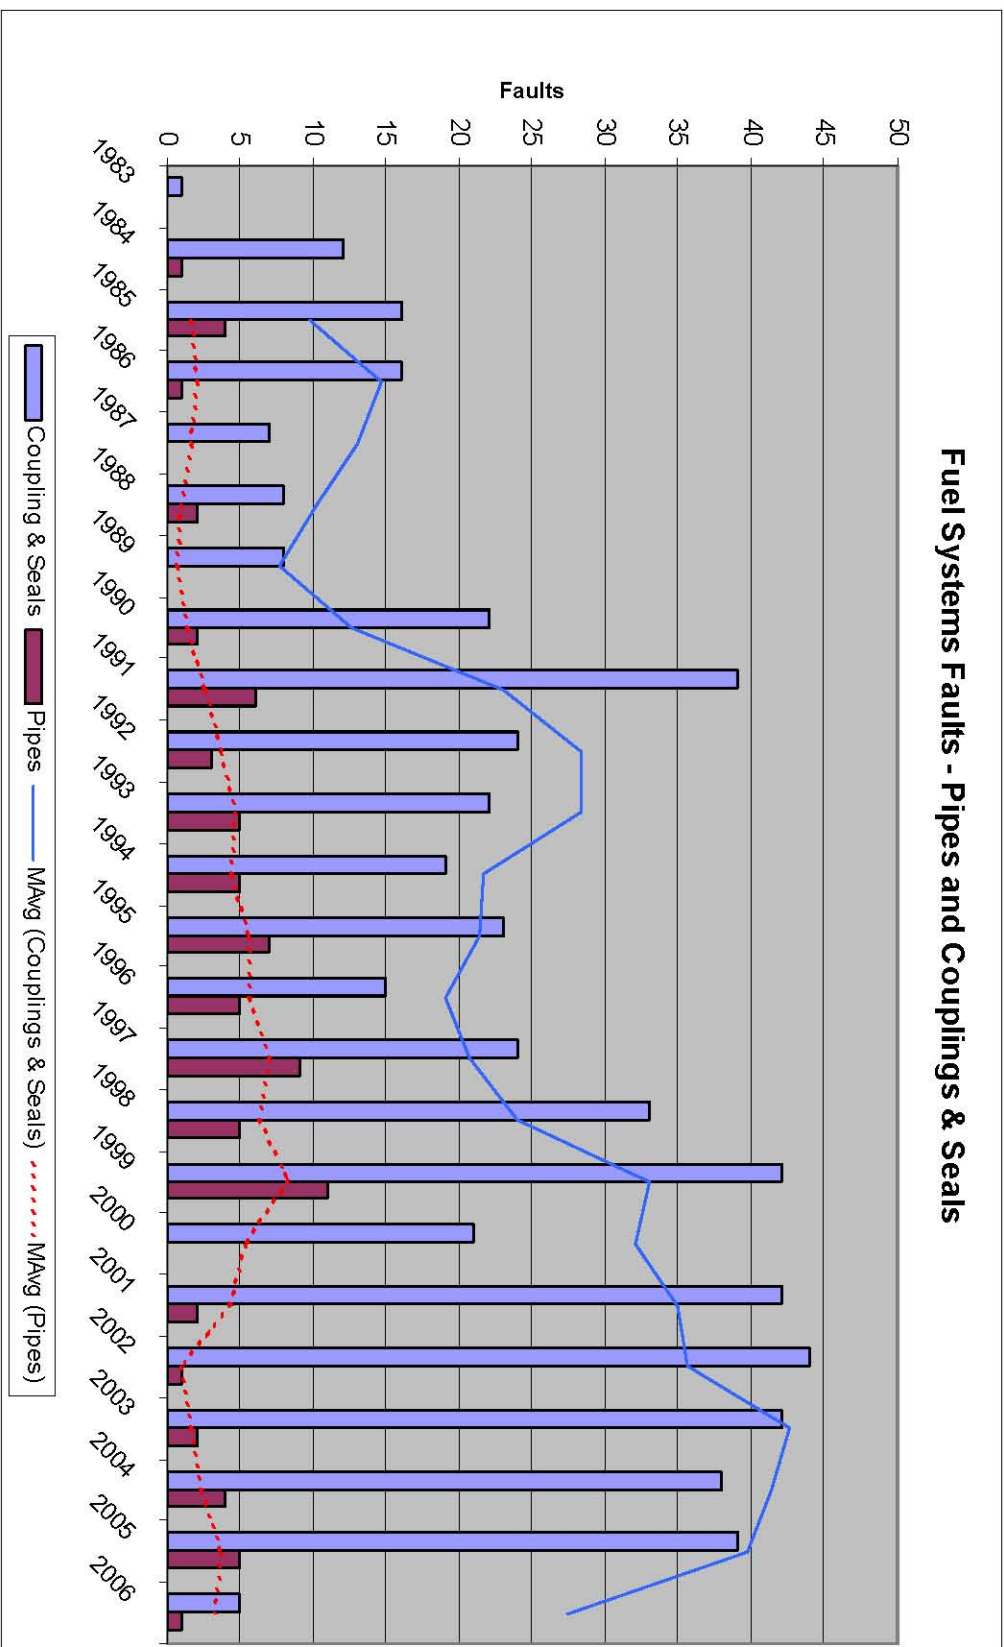
Figure 1 – Graph of Fuel Leak Faults from Fuel Pipes and from Couplings and Seals by Year

Nimrod fleet maintenance data from 1983 to 2006 indicates that there has been a continual increase in fuel leaks over time: the average for the fleet per annum in the 1980s was 10, it had risen to 40 per annum between 2000 and 2005, despite the reduction in Nimrod fleet size. The great majority of fuel leaks are from couplings. In the absence of other factors, the reason for the increase in leaks over time might be that the seals are proving less effective as they age. The 2 aircraft that have been Nimrod R1s since their construction show no increase in fuel leaks over time. While this might be attributable to their operating in a more benign, higher-level, environment than the MR2, the small size of the Nimrod R1 fleet makes it difficult to draw meaningful comparisons.
