**ROYAL AIR FORCE
PROCEEDINGS OF A BOARD OF INQUIRY
INTO AN AIRCRAFT ACCIDENT**

To inquire into an accident involving NIMROD MR2 XV230 on 2 SEP 06.

CONCLUSIONS OF THE BOARD

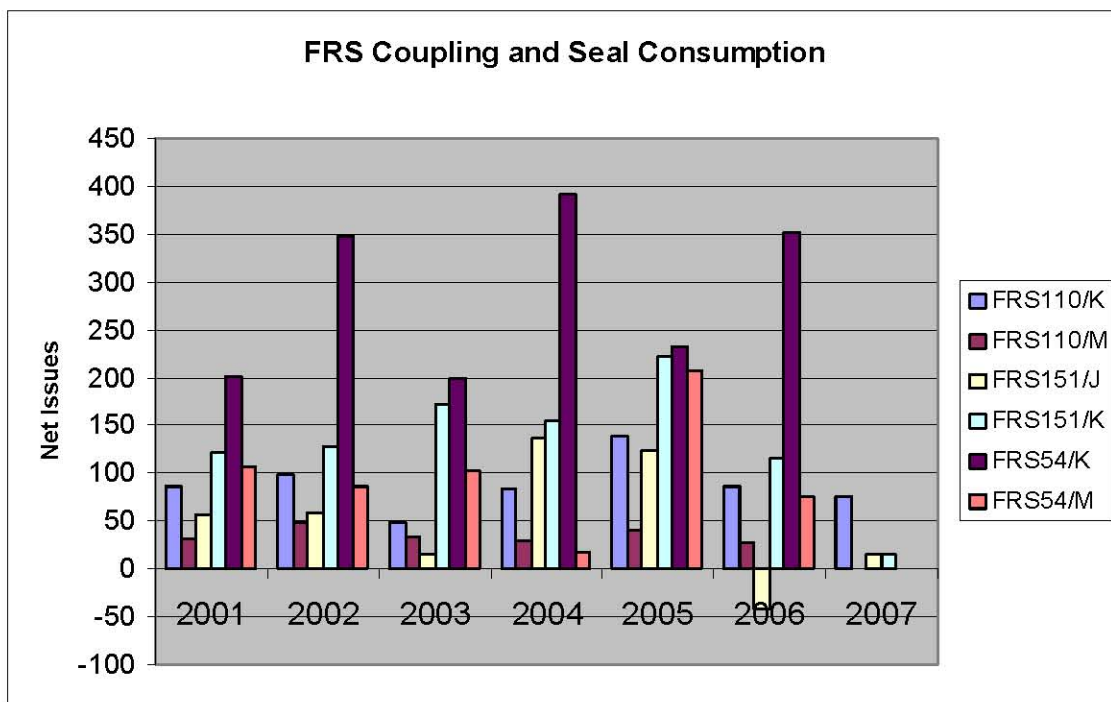
Figure 1 – Graph of Fuel Coupling and Seal Net Consumption by Year

3. **Analysis of Fuel Leak from Pipes, Couplings and Seals.** The data for fuel leaks from pipes, and from couplings and seals, by aircraft tail number and year are given at Appendix 1, Tables 1 and 2 respectively. This shows a low and stable occurrence rate for leaks from fuel pipes, but a distinct increasing trend in leaks from couplings and seals over the same period (see Appendix 1, Figure 1). There is an increase in the average number of connector faults across the fleet for each of the 3 decades covered. There was an average of 10 faults per annum in the 1980s, 26 in the 1990s and 38 per year since 2000. This increase must be seen against a decreasing fleet size. When the fault rate per airframe in the Nimrod fleet is calculated (Appendix 1, Table 3), the increasing trend in fuel leaks from couplings and seals is clearly apparent (Appendix 1, Figure 2). The annual number of leaks per airframe increasing from almost none in 1983 to 1.7 leaks per airframe per annum between 2000 and 2005. The low number of faults recorded in 2006 is attributed to the fact that not all maintenance work orders from that year had been loaded on the maintenance data system at the time of data capture (Oct 06). The high number of faults recorded in 1999 is partly attributed to Nimrod R1 XV249 (36%), which was subject to a major fuel leak investigation in that year. The number of faults recorded for XV230 is below the norm for the fleet.
